NASA Contractor Report 165784

EFFECT OF MATRIX RESIN ON THE IMPACT FRACTURE  
CHARACTERISTICS OF GRAPHITE-EPOXY LAMINATES

P. E. Hertzberg, B. W. Smith, and A. G. Miller

Boeing Commercial Airplane Company  
Seattle, Washington

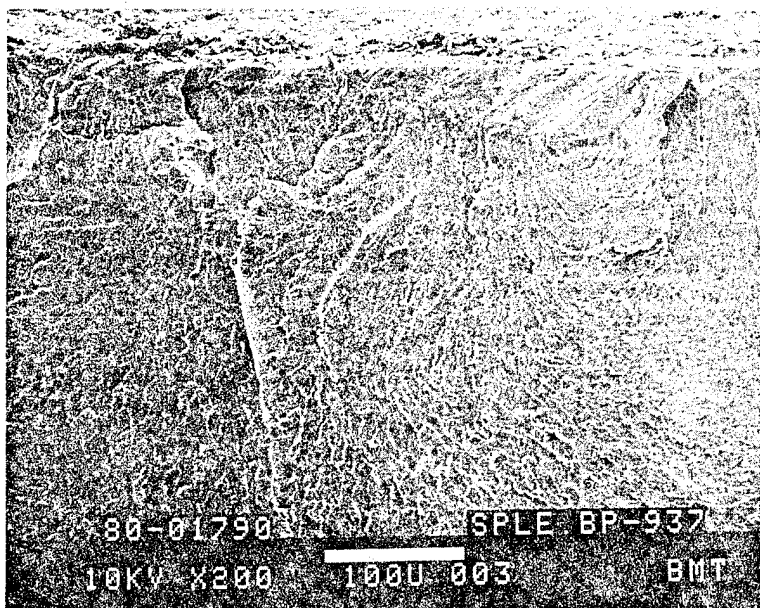
Figure 8. Neat Resin Fracture, Cycom 937 (200X)

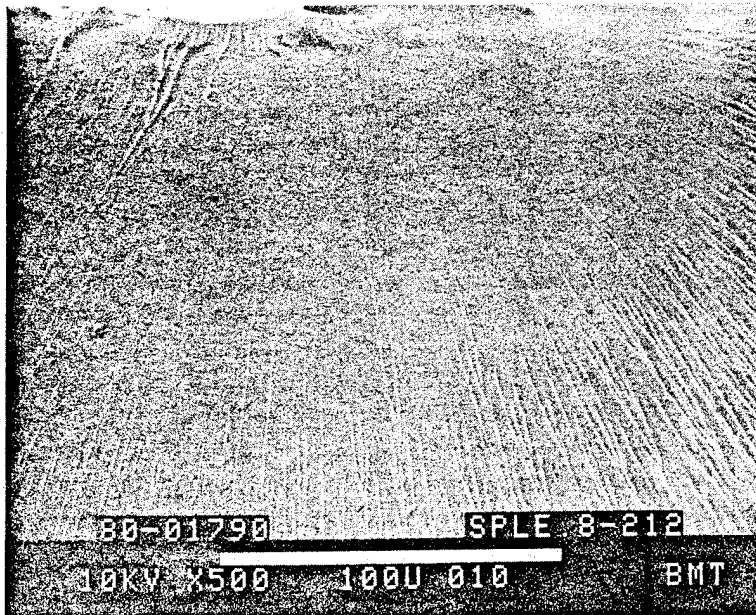
Figure 9. Fracture Origin, Neat Resin, Narmco 5208 (500X)

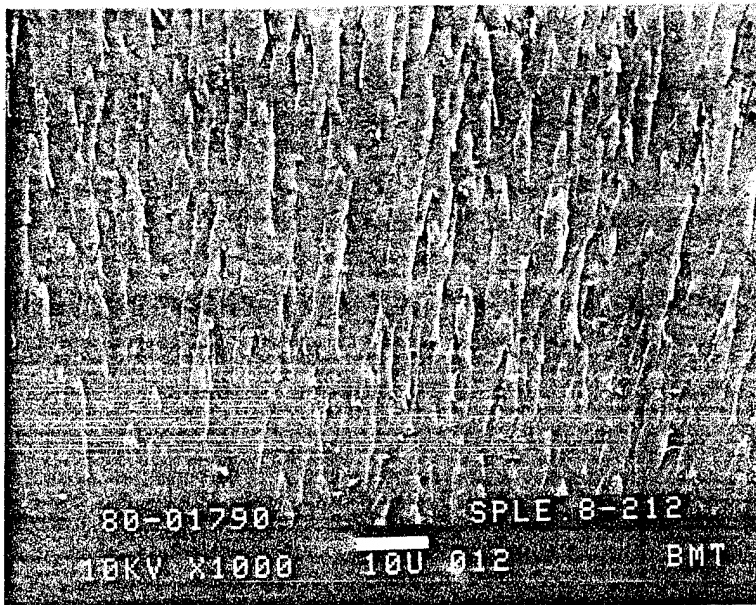
Figure 10. Crack Propagation, Neat Resin, Narmco 5208 (1000X)

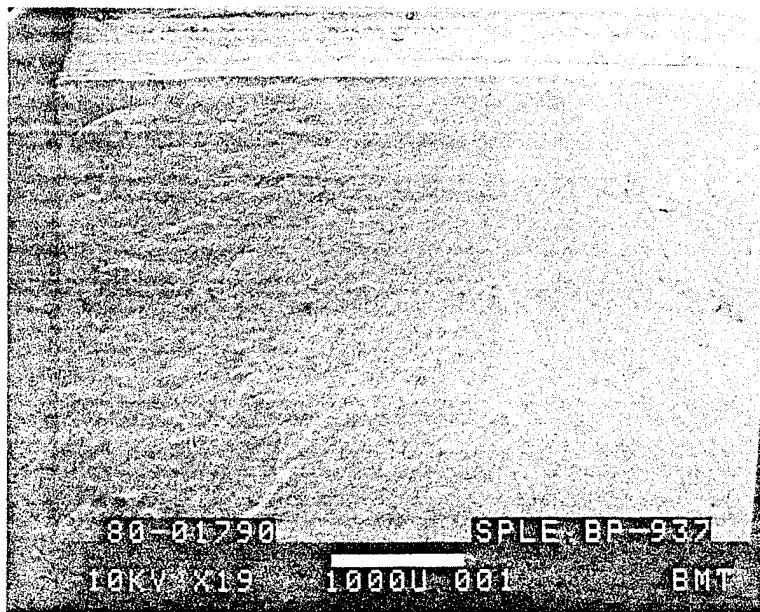
Figure 11. Fracture Origin, Neat Resin, Cycom 937 (10,000X)

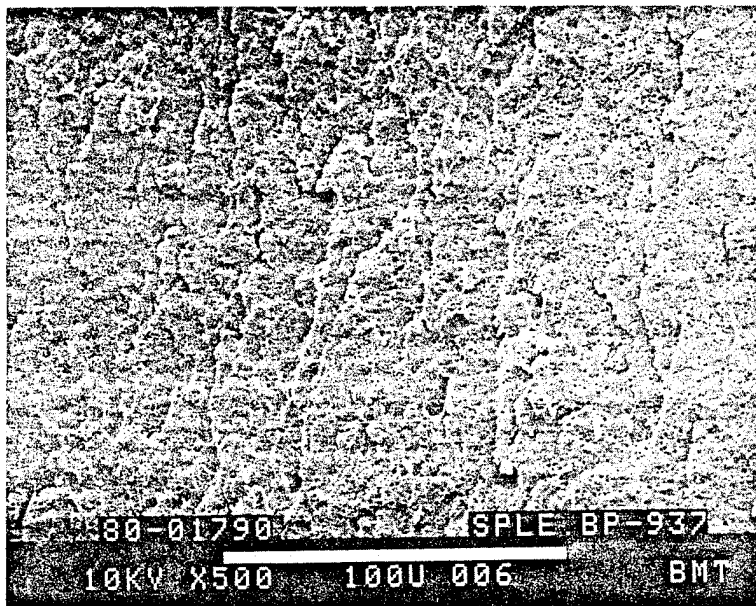
Figure 12. Crack Propagation Zone, Neat Resin, Cycom 937  
(50,000X)

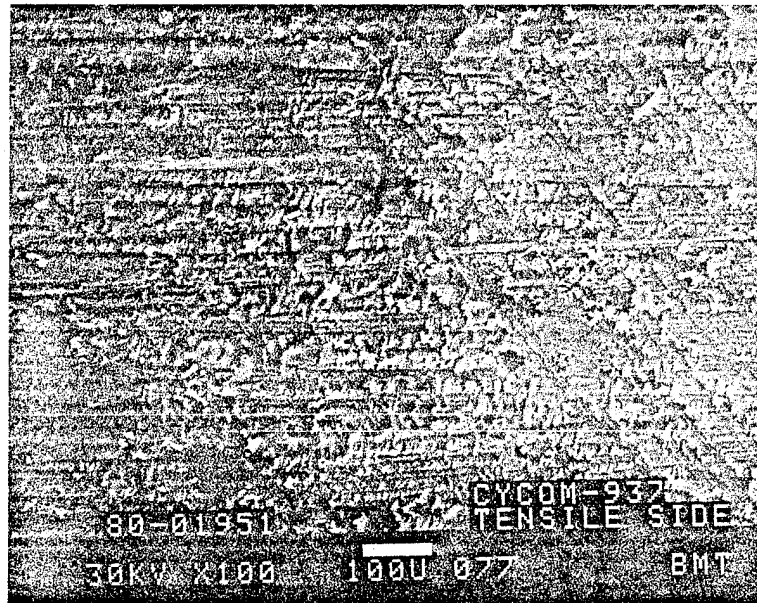
Figure 15. Interlaminar Fracture, Cycom 937 (100X)

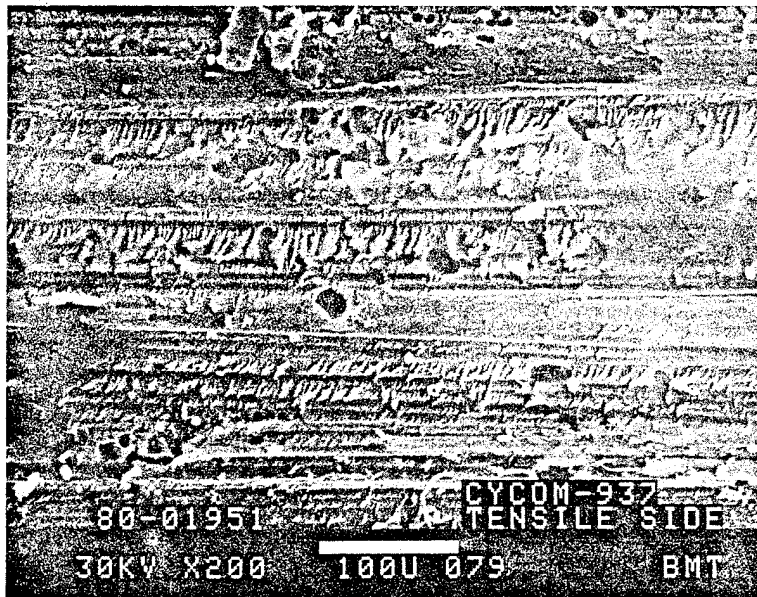
Figure 16. Interlaminar Fracture, Cycom 937 (200X)

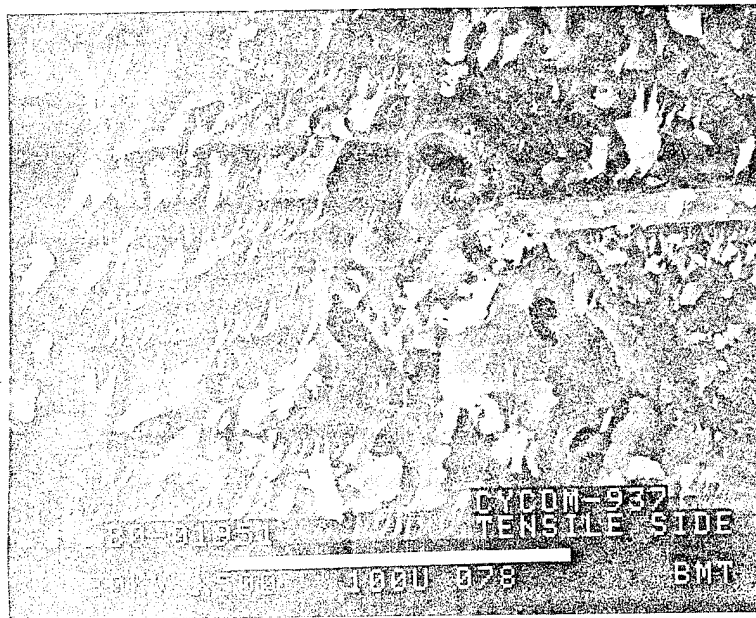
Figure 17. Interlaminar Fracture, Cycom 937 (500X)

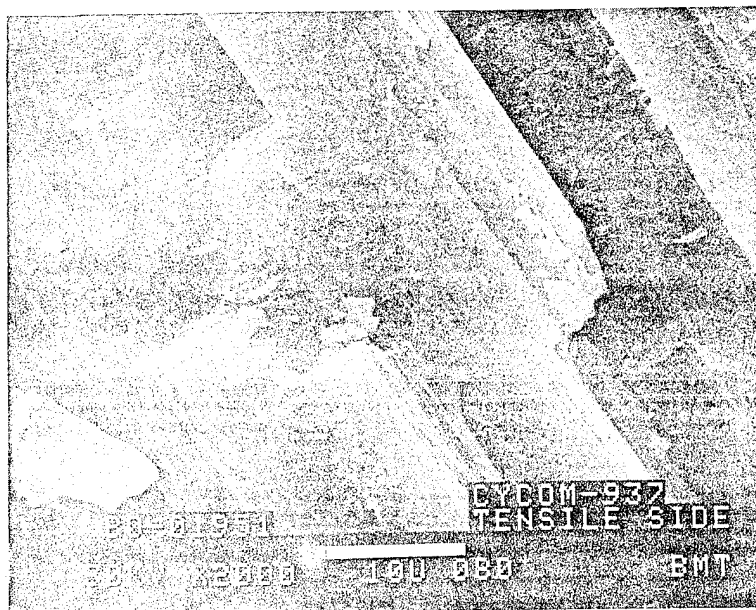
Figure 18. Interlaminar Fracture, Cycom 937 (2000X)

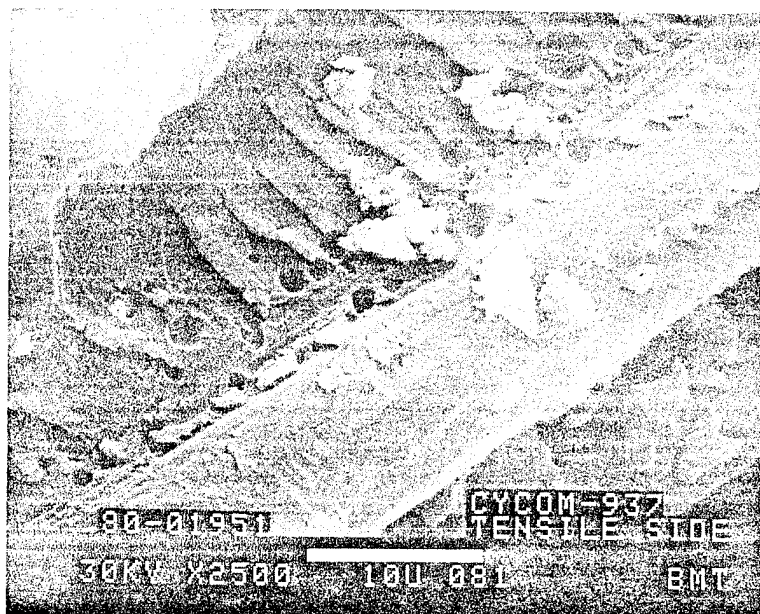
Figure 19. Resin-Fiber Bonding, Cycom 937 (2500X)

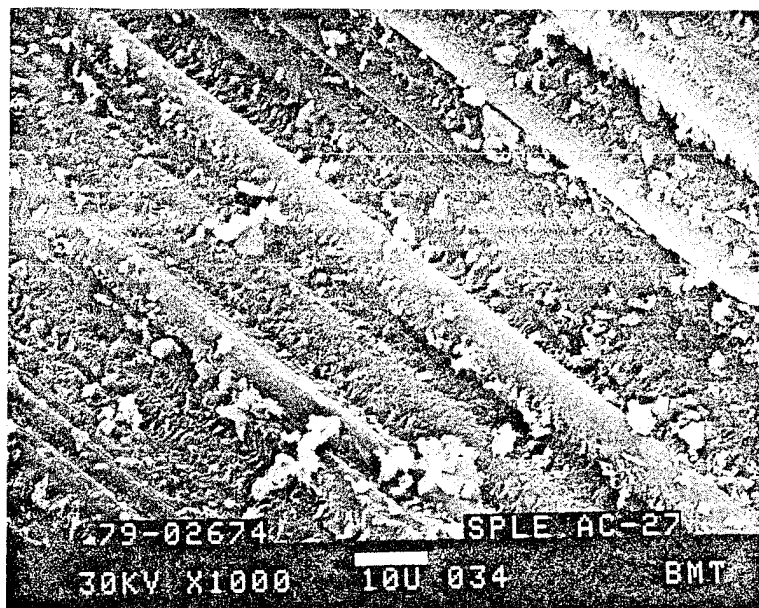
Figure 20. Static Notched Tension Failure, Origin, Cycom 937 (1000X)

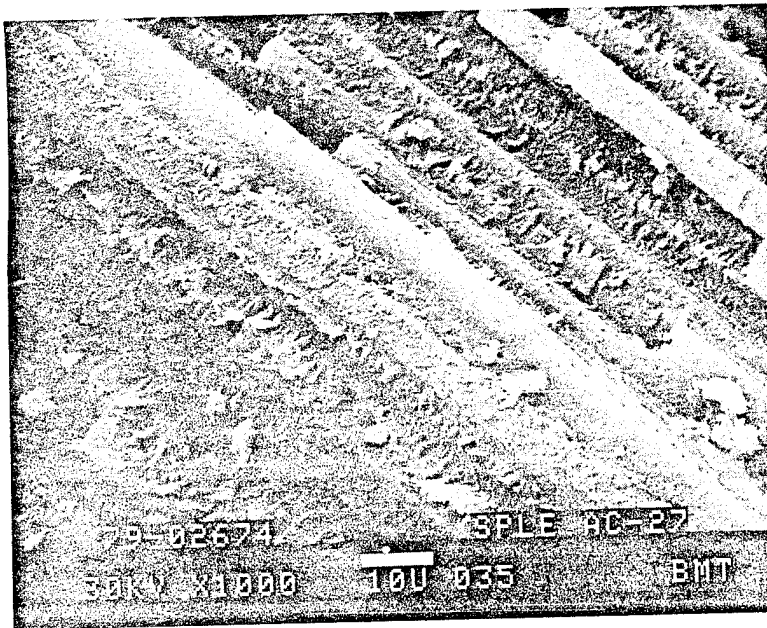
Figure 21. Static Notched Shear Failure, Propagation Zone, Cycom 937 (1000X)

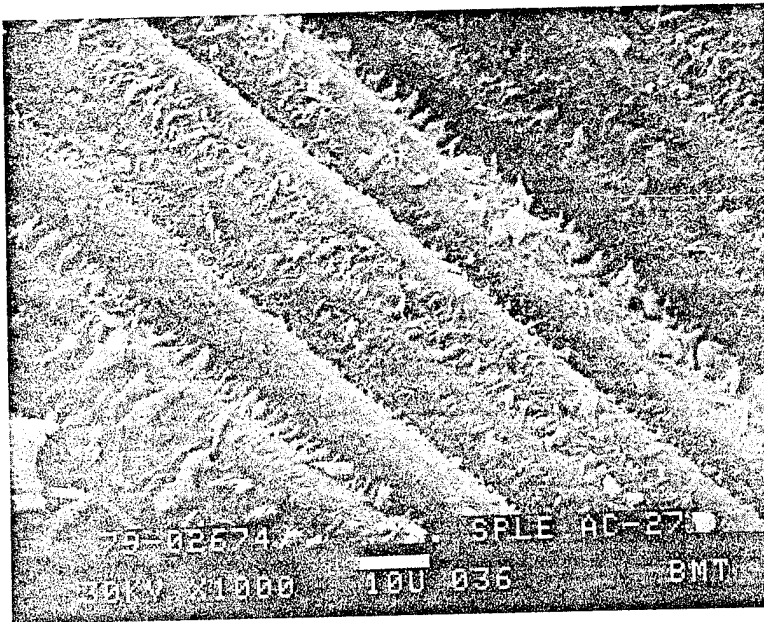
Figure 22. Static Notched Shear Failure, Different Area, Cycom 937 (1000X)

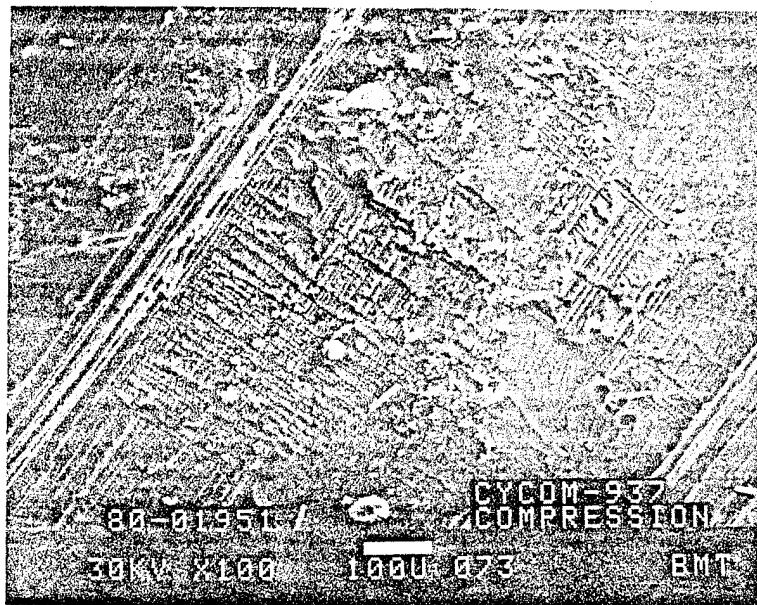
Figure 23. Compression-Loaded Interlaminar Shear Failure, Cycom 937 (100X)

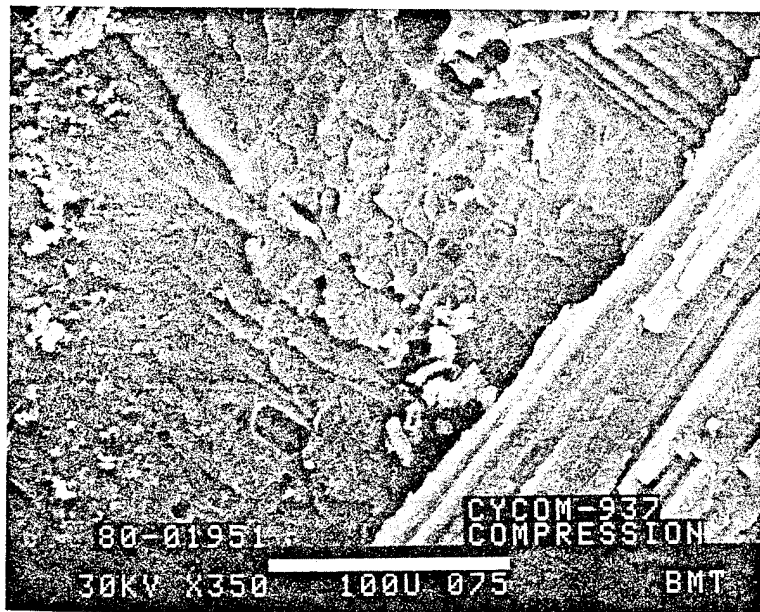
Figure 24. Compression Shear Delamination (Note Voids), Cycom 937 (350X)

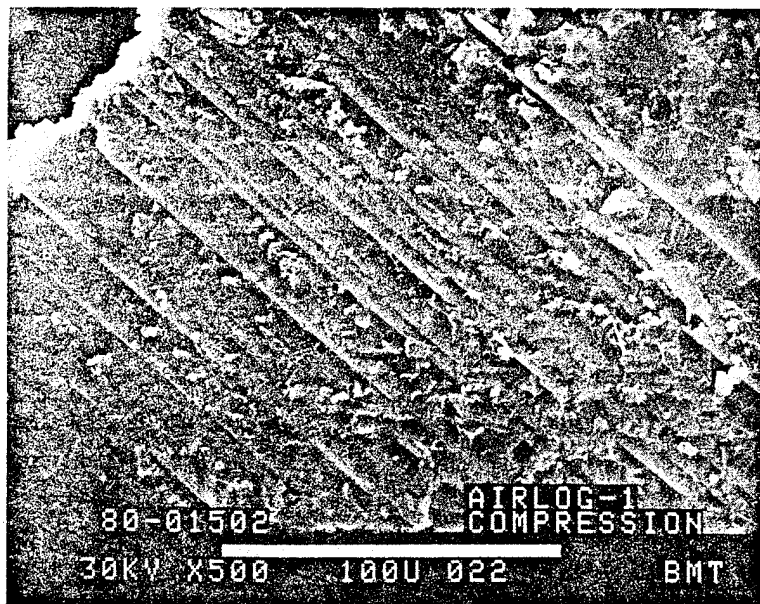
Note plastic flow between fibers.

Figure 36. Compression Shear, Air Logistics 1 (500X)

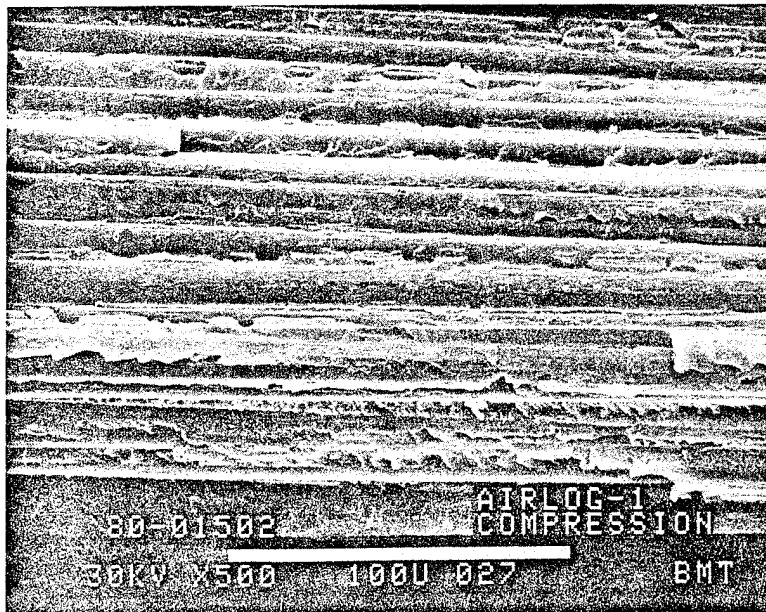
Figure 37. Transverse Compression Intraply Failure, Air Logistics 1 (500X)

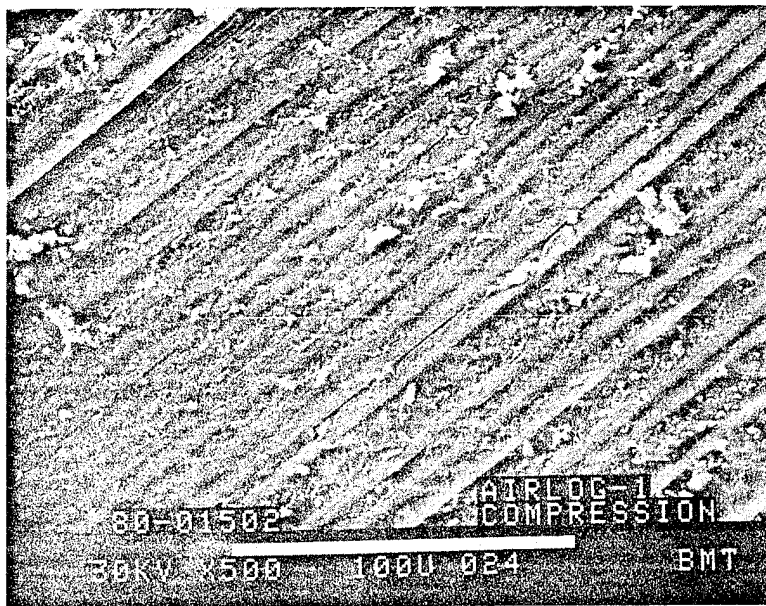
Figure 38. Compression Shear With Large Plastic Flow, Air Logistics 1 (500X)

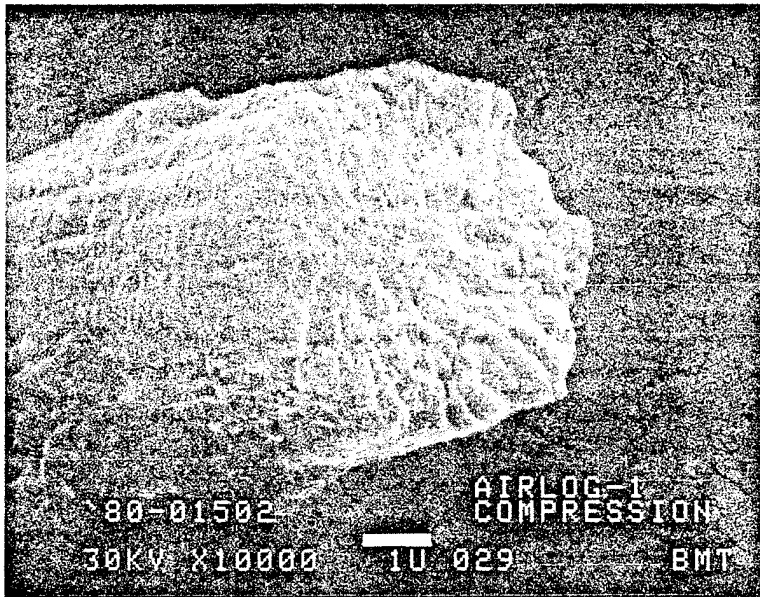
Figure 40. Fiber-Matrix Bond, Compression Side, Air Logistics 1 (10,000X)

Note cohesive failure.

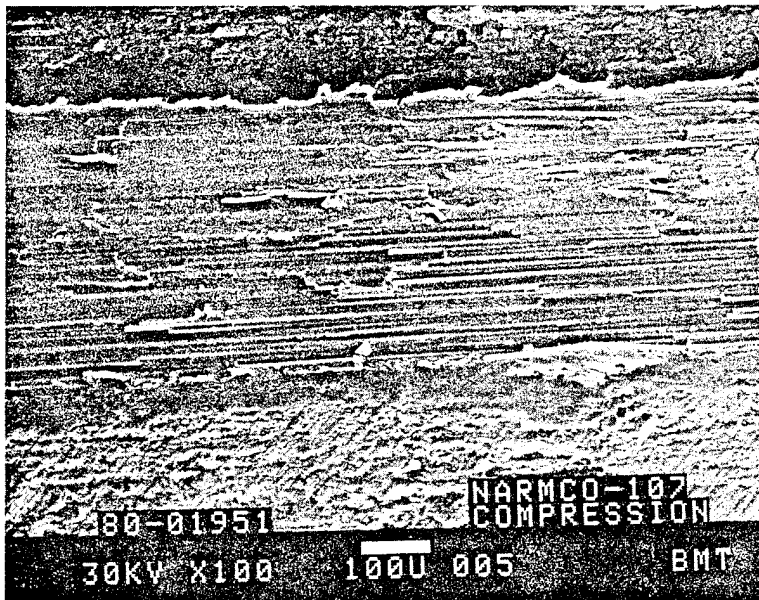
Figure 48. Transverse Fracture from Compression Side, Narmco 107 (100X)

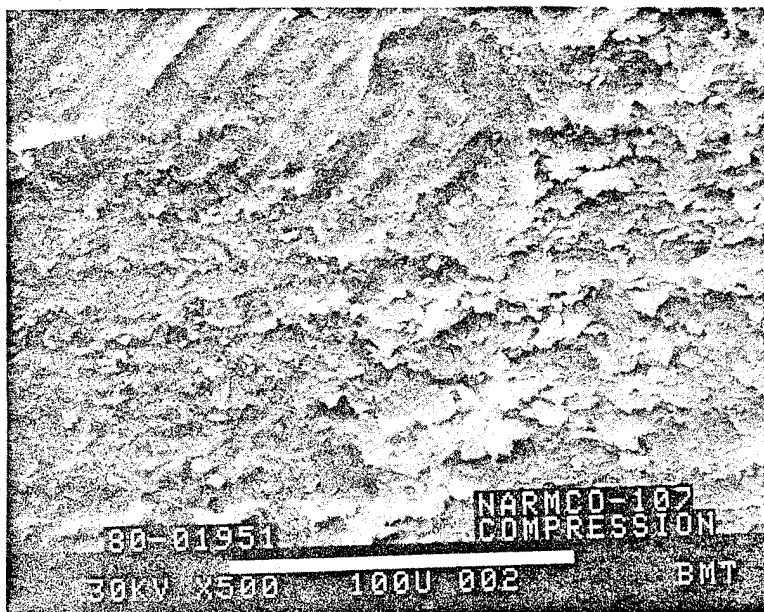
Figure 49. Compression Shear, Narmco 107 (500X)

Note: Same area as figure 47.

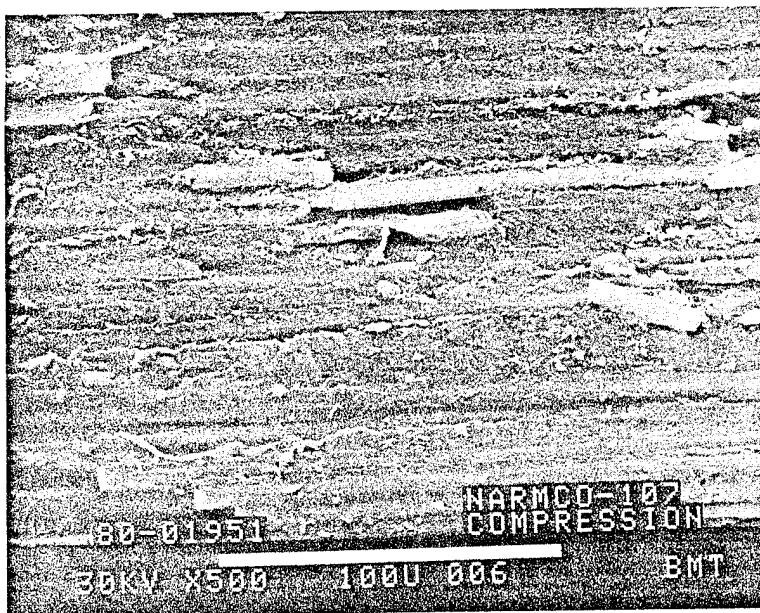
Figure 50. Transverse Fracture of 90-deg Ply, Narmco 107 (500X)

Note: Same area as figure 48.

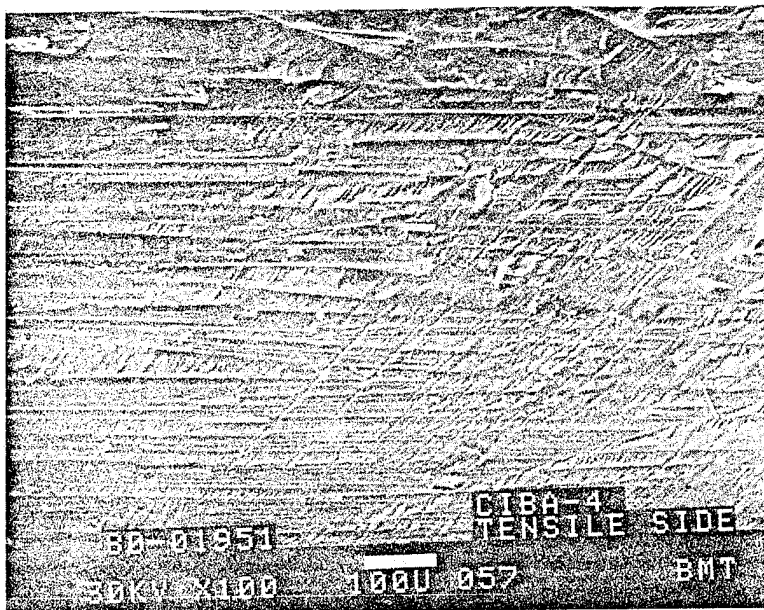
Figure 54. Delamination Fracture, Tension Side, Ciba 4 (100X)

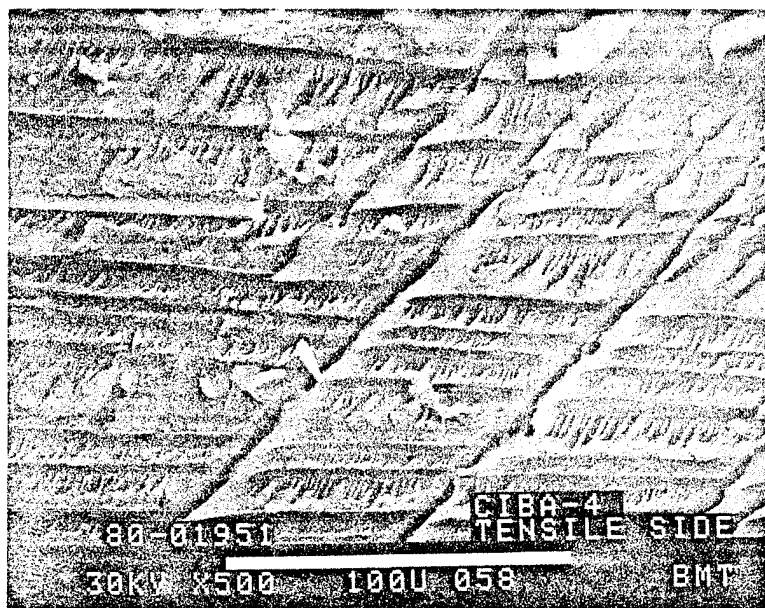
Figure 55. Apparent Brittle Fracture, Delamination Face, Ciba 4 (500X)

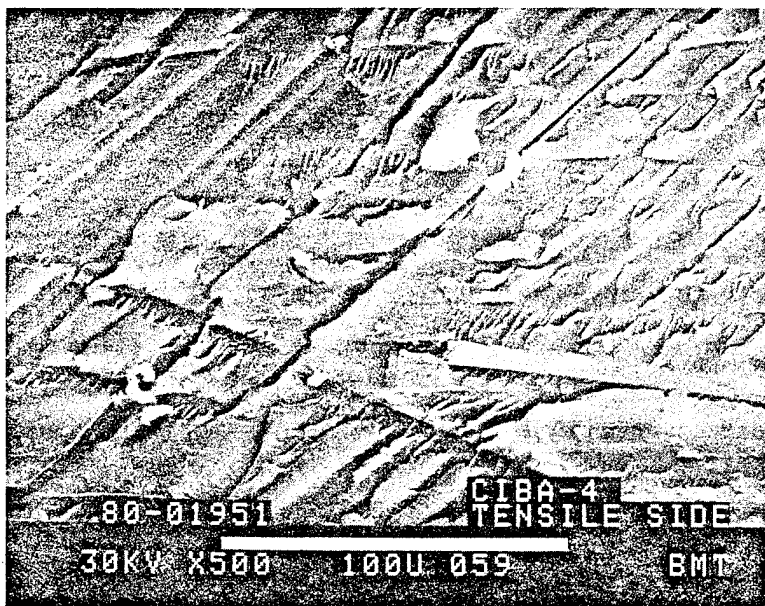
Figure 56. Apparent Brittle Fracture, Ciba 4 (500X)

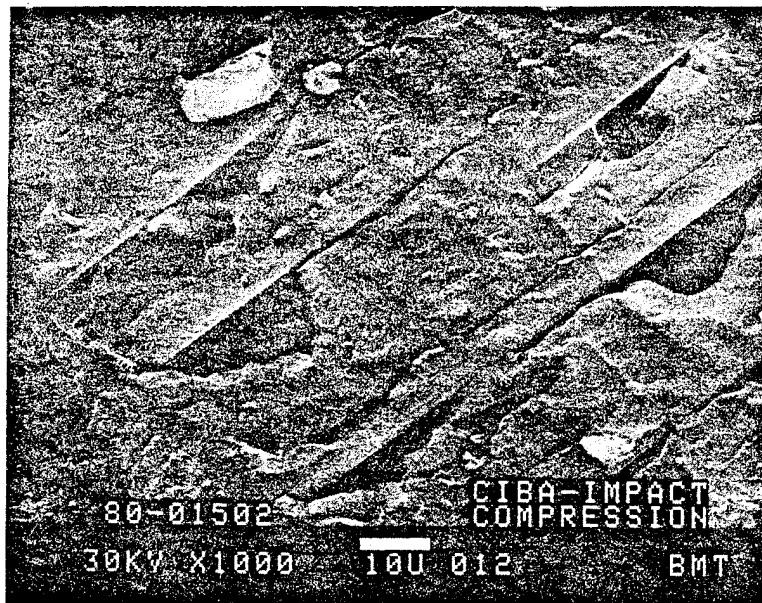
Figure 76. Influence of Voids on Fracture, Ciba 1M (1000X)

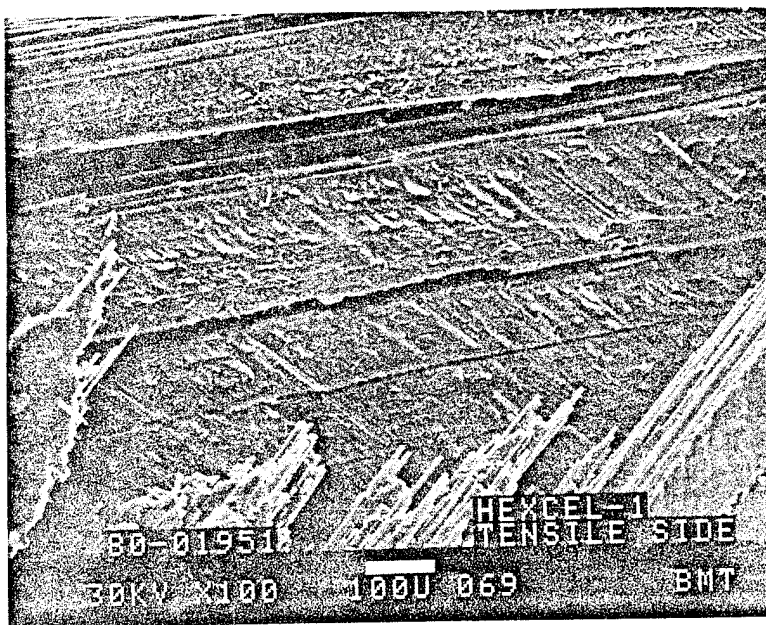
Figure 77. Delamination Plane with Transverse Cracks, Hexcel 1 (100X)

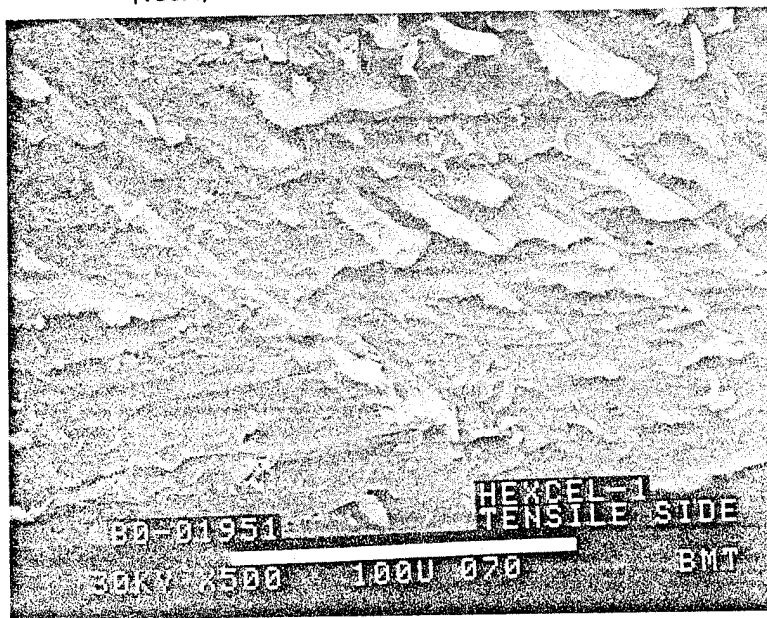
Figure 78. Plastic Flow on Shear Interlaminar Plane, Hexcel 1 (500X)

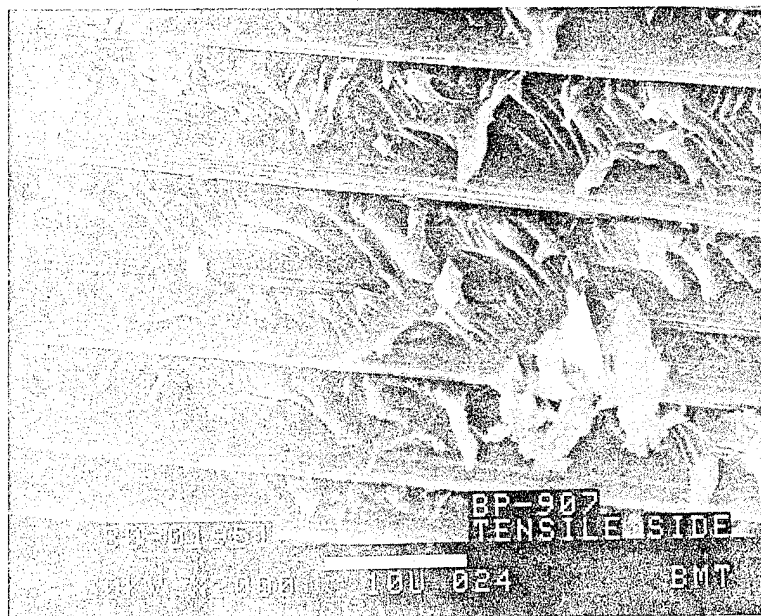
Figure 97. Ductile Resin Failure, BP-907 (2000X)

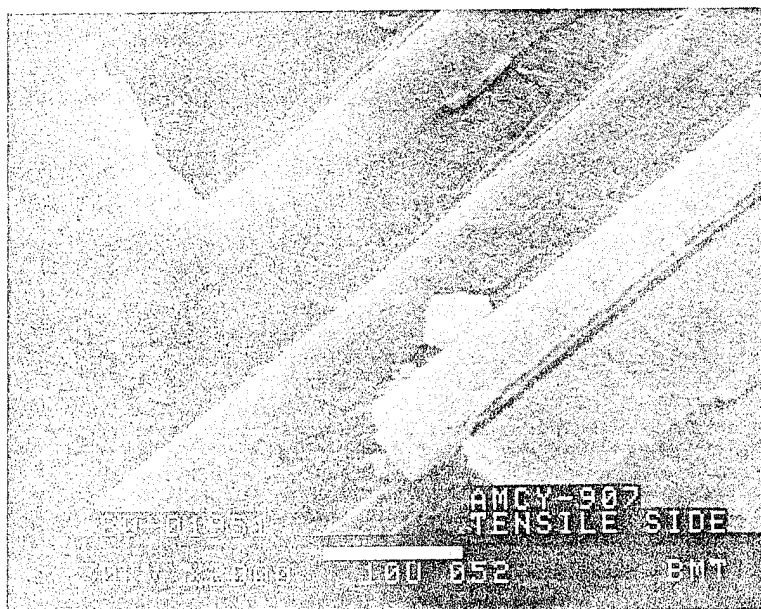
Figure 98. Brittle Cleavage Failure, BP-907-LR (2000X)

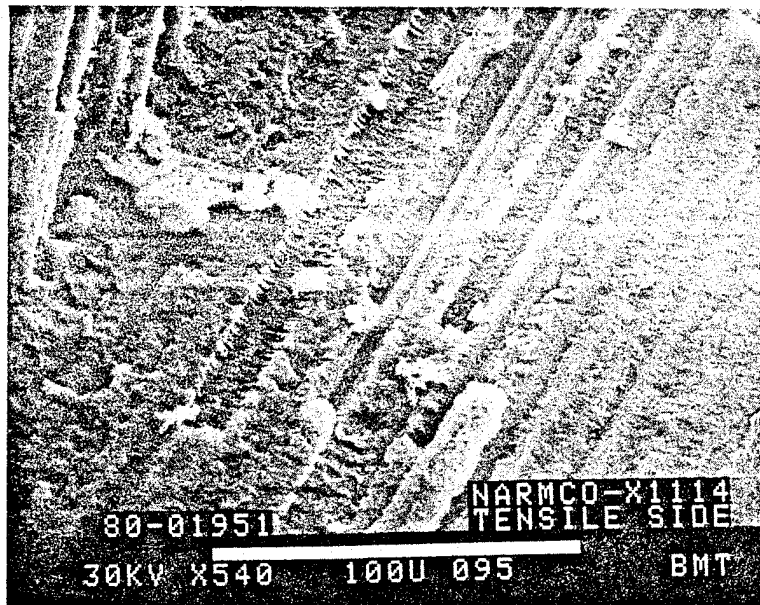
Note stretched and collapsed resin.

Figure 112. Tension Failure, 90-deg Ply, Narmco X1114 (540X)

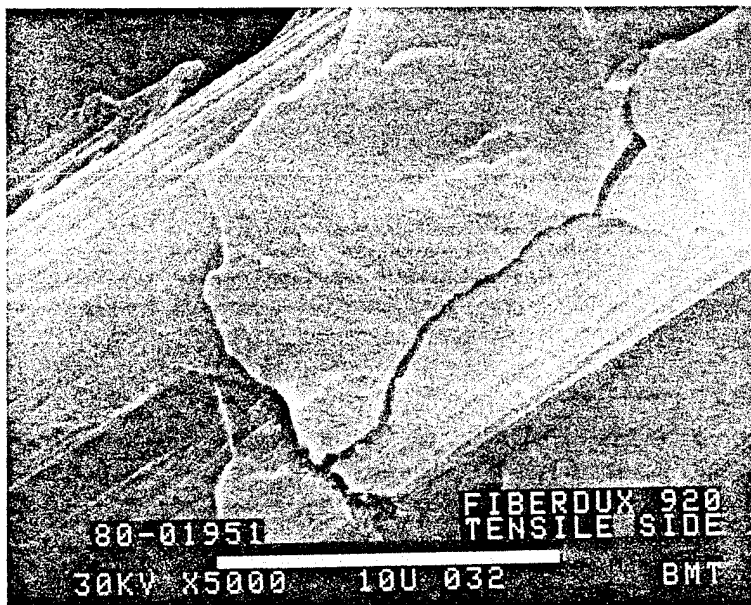
Figure 124. Crack Propagation After Fiber Failure, Fibredux 920 (5000X)
